CITY OF CHARLOTTESVILLE, VIRGINIA
CITY COUNCIL AGENDA

Technical Memorandum – Smith AFC Natatorium Improvements

TECHNICAL MEMORANDUM Smith AFC Natatorium Improvements June 8, 2015

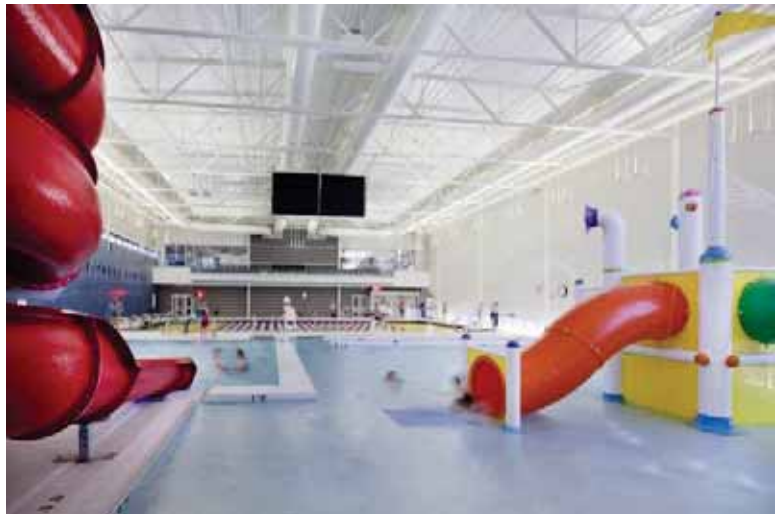
Combined chlorine (CC) forms when free chlorine (FC) reacts with contaminants in the water. When free chlorine reacts with ammonia, inorganic chloramines (not containing carbon) are produced. When FC reacts with organic nitrogen compounds, organic chloramines are formed. Both inorganic and organic chloramines show up in pool water tests as combined chlorine (CC) and are generally called chloramines. Urine, sweat and the environment are sources of ammonia and organic nitrogen-containing compounds. It is important to know how much of total chlorine is comprised of CC as CC is not an effective disinfectant. The presence of combined chlorine poses several challenges that the facility staff must work to address. Chloramines evaporate and are the cause of chlorine-like smell often witnessed in indoor pools. Chloramines are also irritating to skin and mucous membranes. Thus the removal or destruction of combined chlorine is a common problem pool operators must work to solve.

In an indoor pool, when one smells ‘chlorine’, what one is actually sensing is the presence of chloramines. **Chloramines are a by-product of the work the chlorine does as a sanitizer**, generated by the chemical reaction between the chlorine and that which it sanitizes. They enter the air as water is evaporated or migrates on skin or in swimsuits, as a result of splashing, or through general agitation of the water. It should be noted that play features – such as slides and sprayers – agitate water and lead to accelerated evaporation of chloramines.

While it is somewhat counter-intuitive, the smell of chloramines does not mean there is too much chlorine in the water. It may in fact mean that there isn’t enough chlorine, or that present chloramines are not being efficiently evacuated from the pool area. The reduction of chloramines in the air is accomplished through air return and exhaust systems.

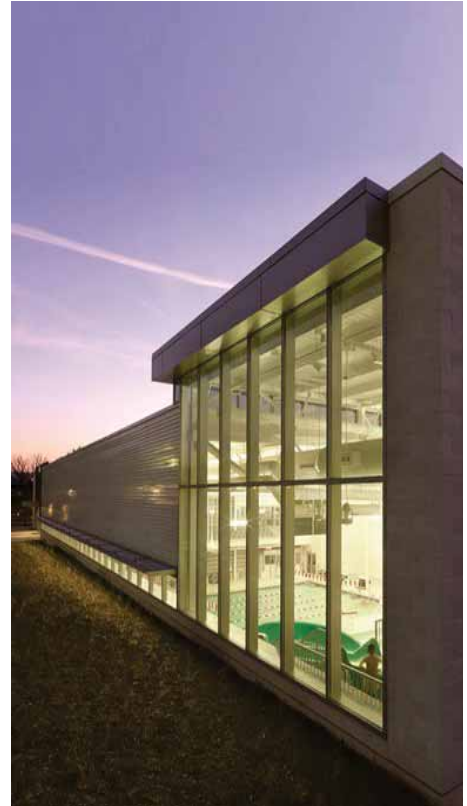
Those systems are considered state of the art. The water is heated efficiently by borrowing energy from the pool air dehumidification system, and further by secondary high efficiency boilers. Pool water is scrubbed by modern large and fine filtering systems. Ultraviolet systems help to destroy biological contaminants and to break down chloramine atoms prior to evaporation. Precision control systems monitor chlorine levels, automatically adjusting chlorine introduction rates to ensure health, balanced pool water.

Collectively, the pool water treatment systems are appropriately and professionally monitored and maintained. Staff consider that there are no design deficiencies, though equipment has been stressed by corrosive airborne chloramine particles, resulting in instances of premature equipment failure and pool downtime.

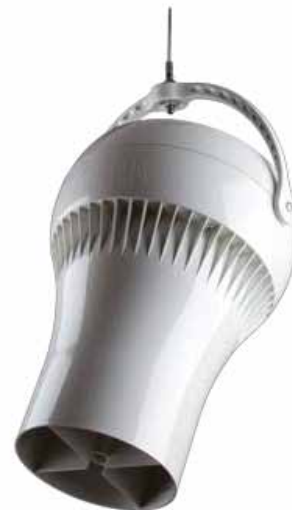
After extensive consultation with project engineers, it was determined that the primary cause of elevated chloramine levels was a ventilation system design deficiency. Heavier-than-air chloramine particles were not mixing with higher air pockets to the extent that they could be effectively drawn from the space via the lowest of the two air returns. As shown in **Figure 1** on page 5, the lowest return duct in the space is located approximately 10' above the pool surface. Smoke tests performed after-hours confirmed that air at lower elevations was overly inert, and that air flow in the across the space from north-to-south toward that register was poor.

A plan was then developed to re-purpose the in-ground supply registers running along with west and northwest walls of the space. The theory was simple. Rather than providing conditioned air to wash the windows, it would draw air off the pool deck along the length of the pool, where heavier-than-air chloramines should be most concentrated. That air would be directly exhausted outside, not mixed with air returned to the space. The existing exhaust air system would be modified, to ensure air pressure between the two sides of the building remained under control, without which too much outside air would be drawn into the building, negatively impacted humidity levels, comfort and energy efficiency. Staff were optimistic that this strategy – easily implemented without disturbing programming and at a reasonable cost – would resolve both air quality and corrosion problems.

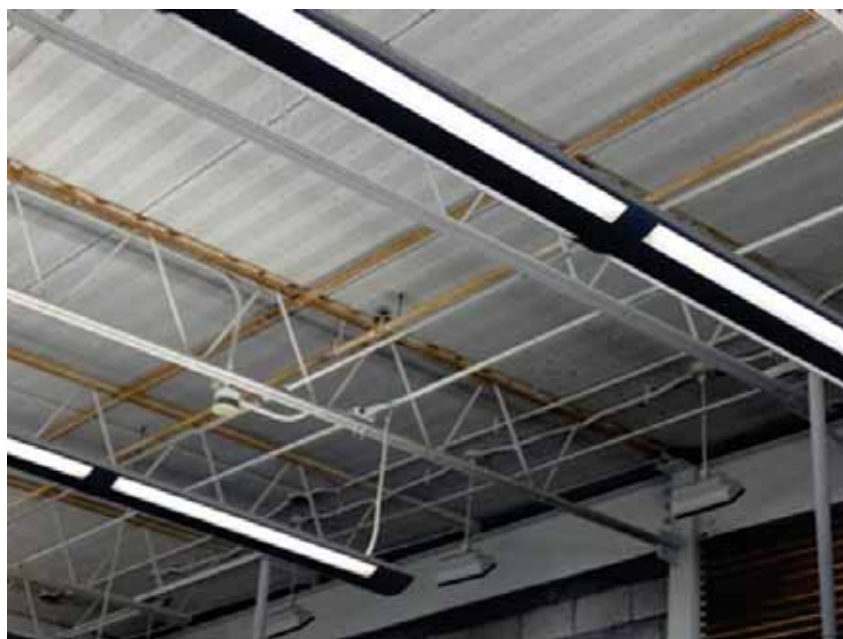
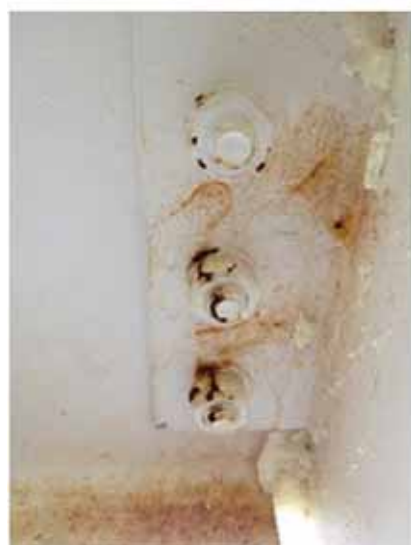
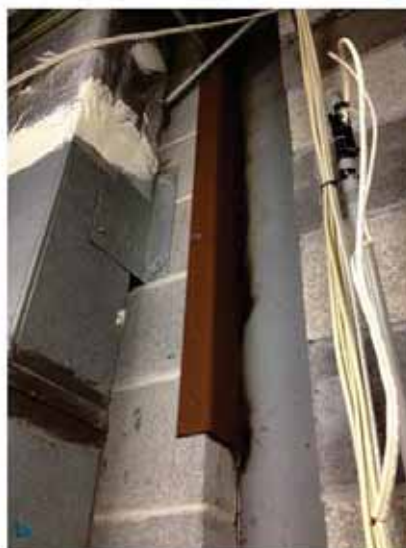
Corrosion of building elements, throughout the entire facility, continued unabated. It's not possible to say whether the reduced chloramine content of the air on most days slowed the corrosion process. Once rust "sets in", it is not easily arrested.

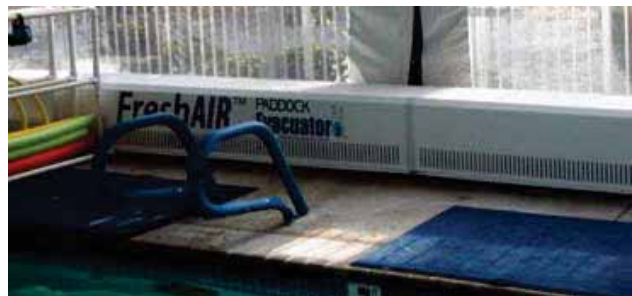
For items 1 and 2, the project team selected a product lined manufactured by Paddock Evacuator, who make systems intended to be installed as an element of new construction and as retrofits for indoor pools with air quality problems. A photo of the selected exhaust bench is shown. Paddock has a series of highly illustrative videos, as well, including:

1. Install a new primary exhaust from the pool deck, incorporated in a factory fabricated plenum box (exhaust bench), which would be mounted down low on the pool deck.
2. Install a 'spot' exhaust system, located on and beneath the slide tower to facilitate air movement from the de-stratification fans.
3. Relocate and redirect the eight existing de-stratification fans to improve air movement.
4. Add a humidity control alarm to alert staff when humidity has exceeded recommended limits.
5. Test, recalibrate and/or replace the existing room pressure sensors for the Fitness Room and the Natatorium, to ensure pool air is not forced into adjacent spaces.
6. Insulate and seal all voids in the Natatorium building envelope, and all wall penetrations separating the Natatorium from the rest of the building.
