# **McIntire Botanical Garden: Environmental Inventory & Impacts Assessment**

December 5, 2011

**GOAL:** Provide a detailed inventory of environmental resources in McIntire Park East and an analysis of the impacts of proposed garden designs

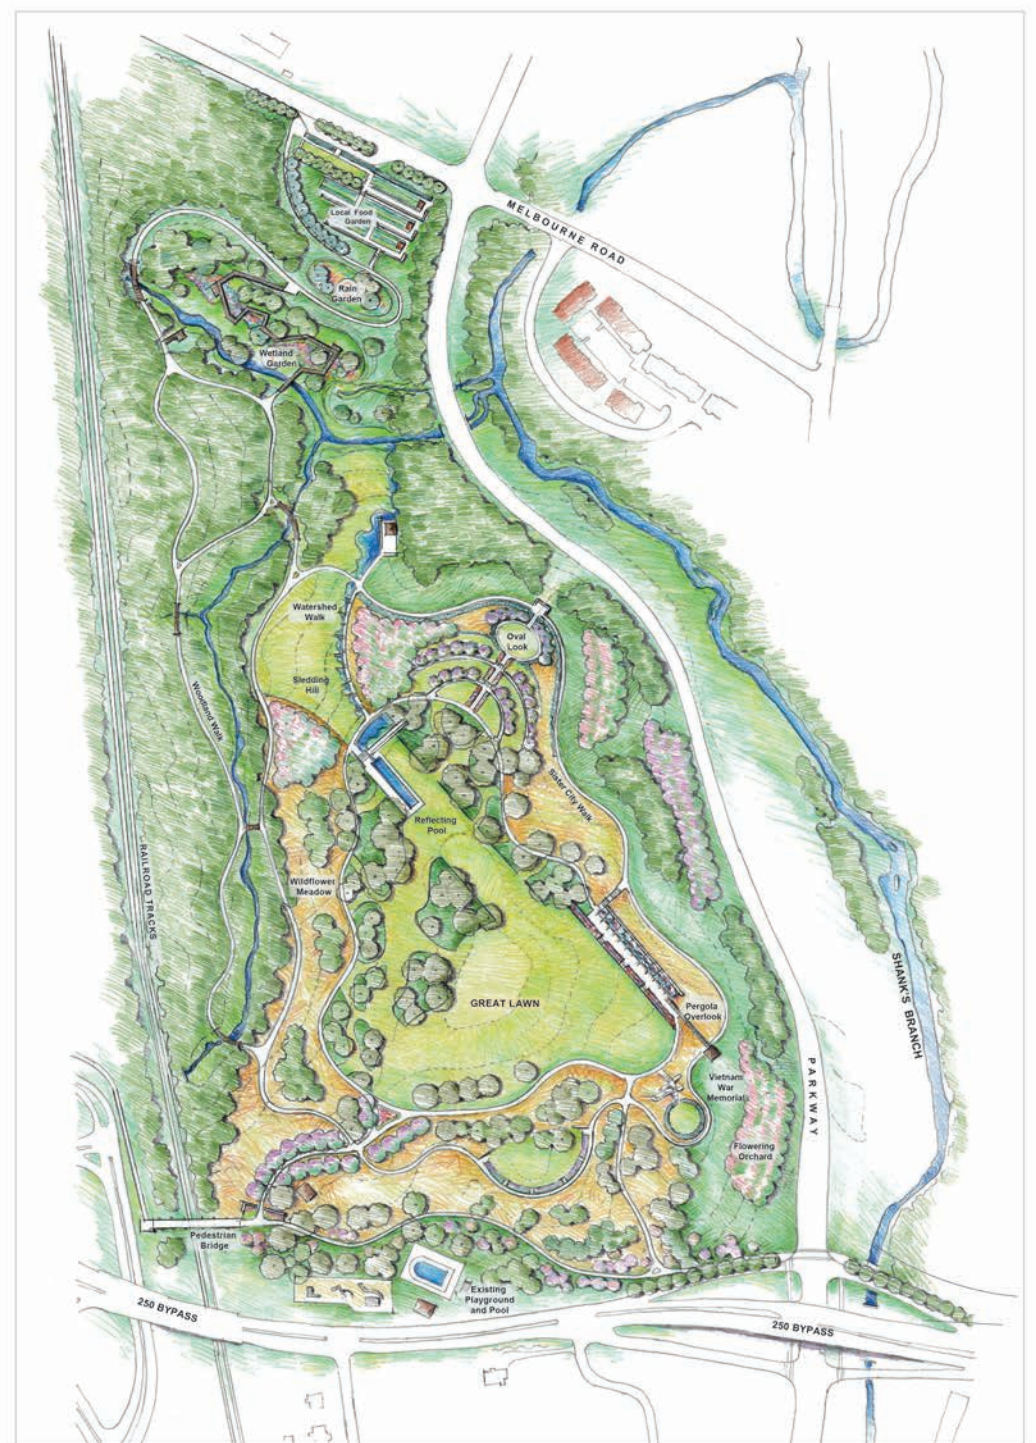
# Garden Proposal: Alternative 1

- Local food garden, rain garden, wetland, orchard, wildflower meadow
- Lawn area with oak trees
- Walking paths
- Wading pool + playground

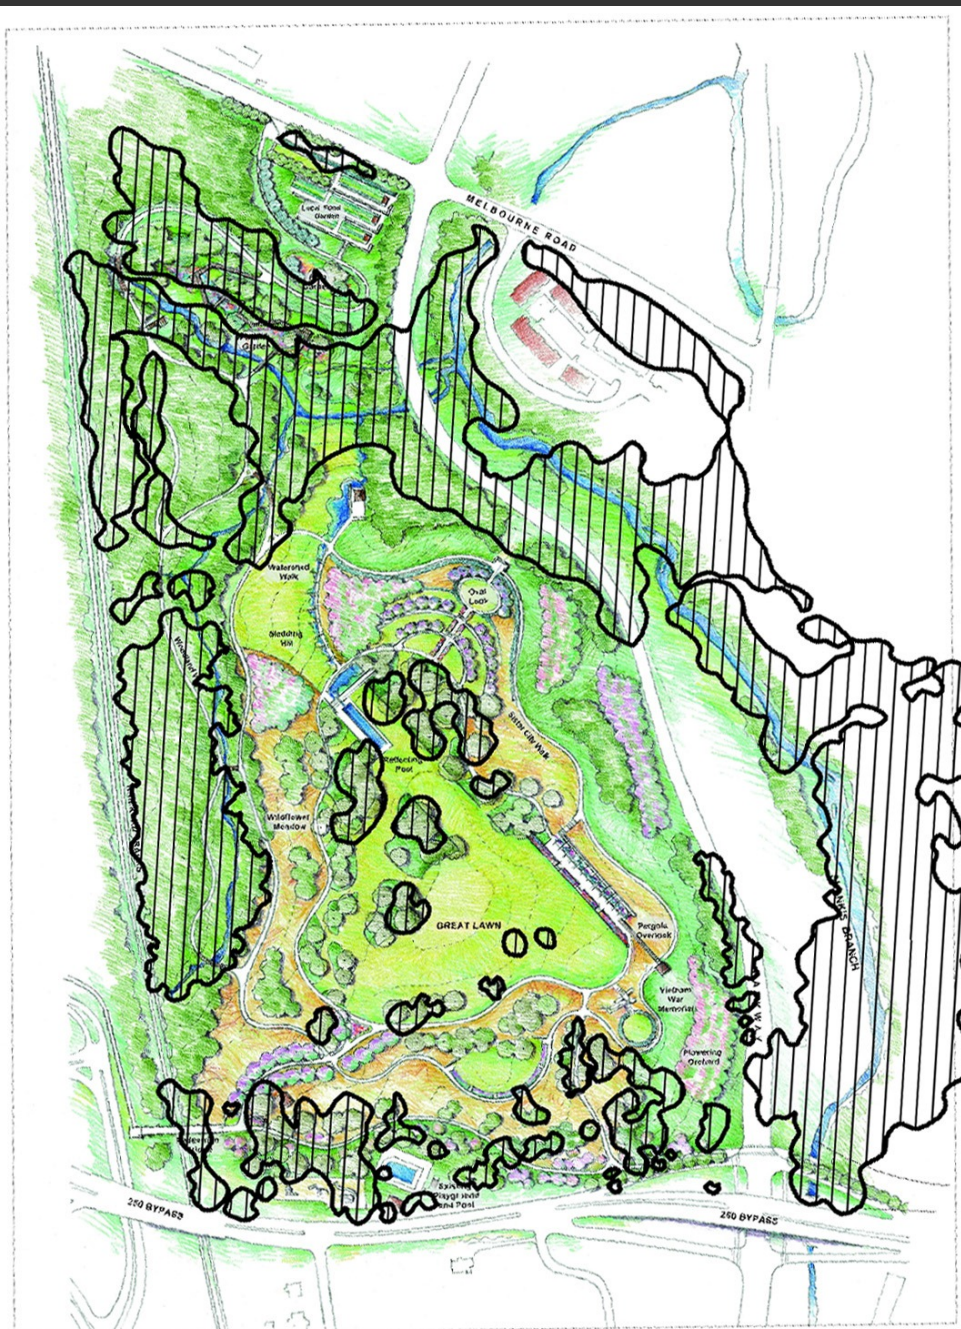
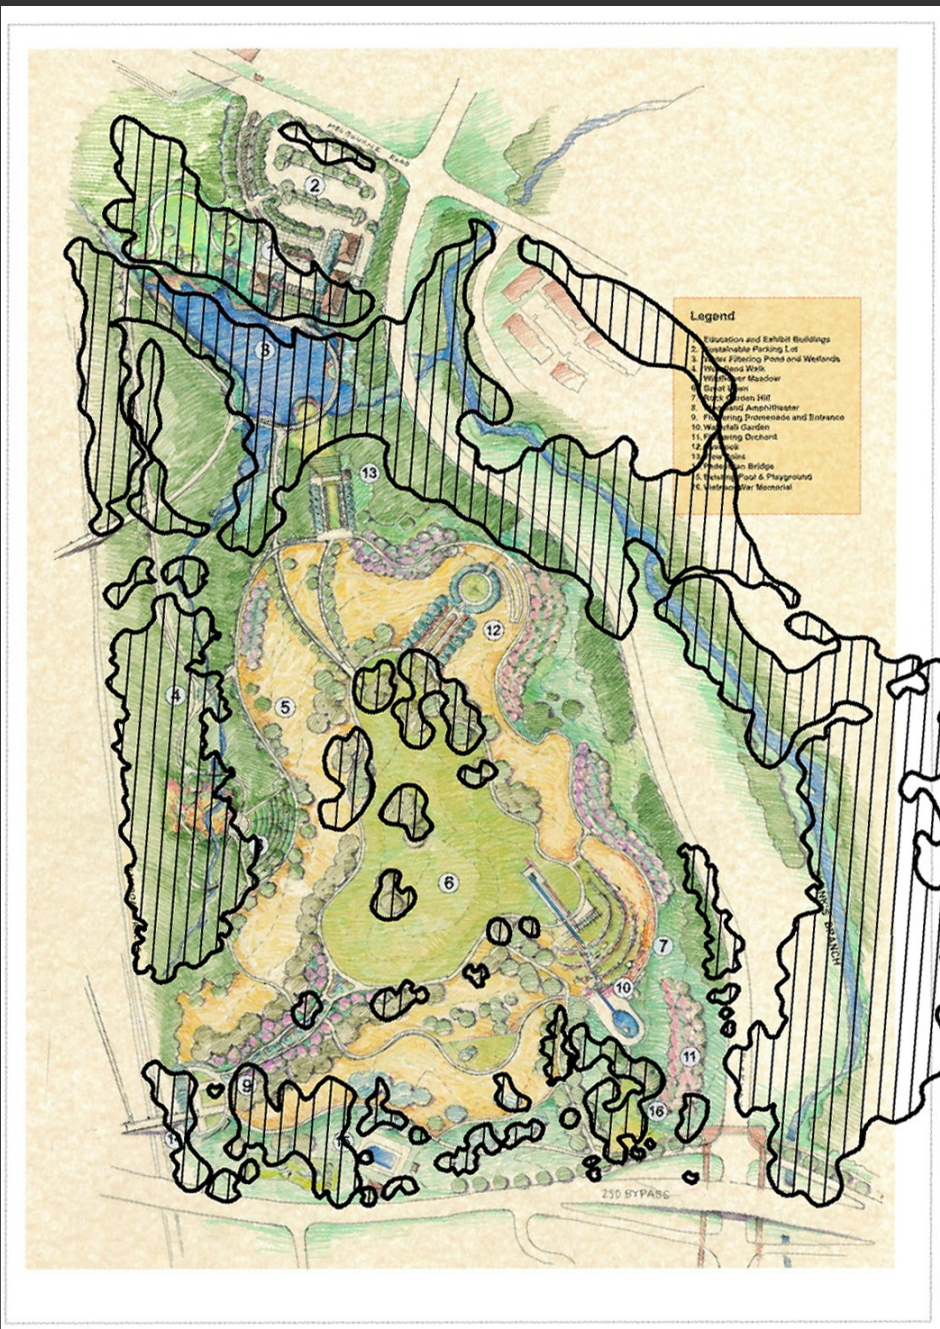
- Legend**
- 1. Education and Exhibit Buildings
  - 2. Sustainable Parking Lot
  - 3. Water Filtering Pond and Wetlands
  - 4. Madflower Meadow
  - 5. Madflower Meadow
  - 6. Great Lawn
  - 7. Flower Hill
  - 8. Amphitheater
  - 9. Flowering Promenade and Entrance
  - 10. Waterfall Garden
  - 11. Flowering Orchard
  - 12. Walk
  - 13. Walk
  - 14. Pergola Bridge
  - 15. Vietnam War Memorial
  - 16. Vietnam War Memorial

McINTIRE BOTANICAL GARDEN  
PLAN STUDY 1

McINTIRE BOTANICAL GARDEN  
PLAN STUDY 2

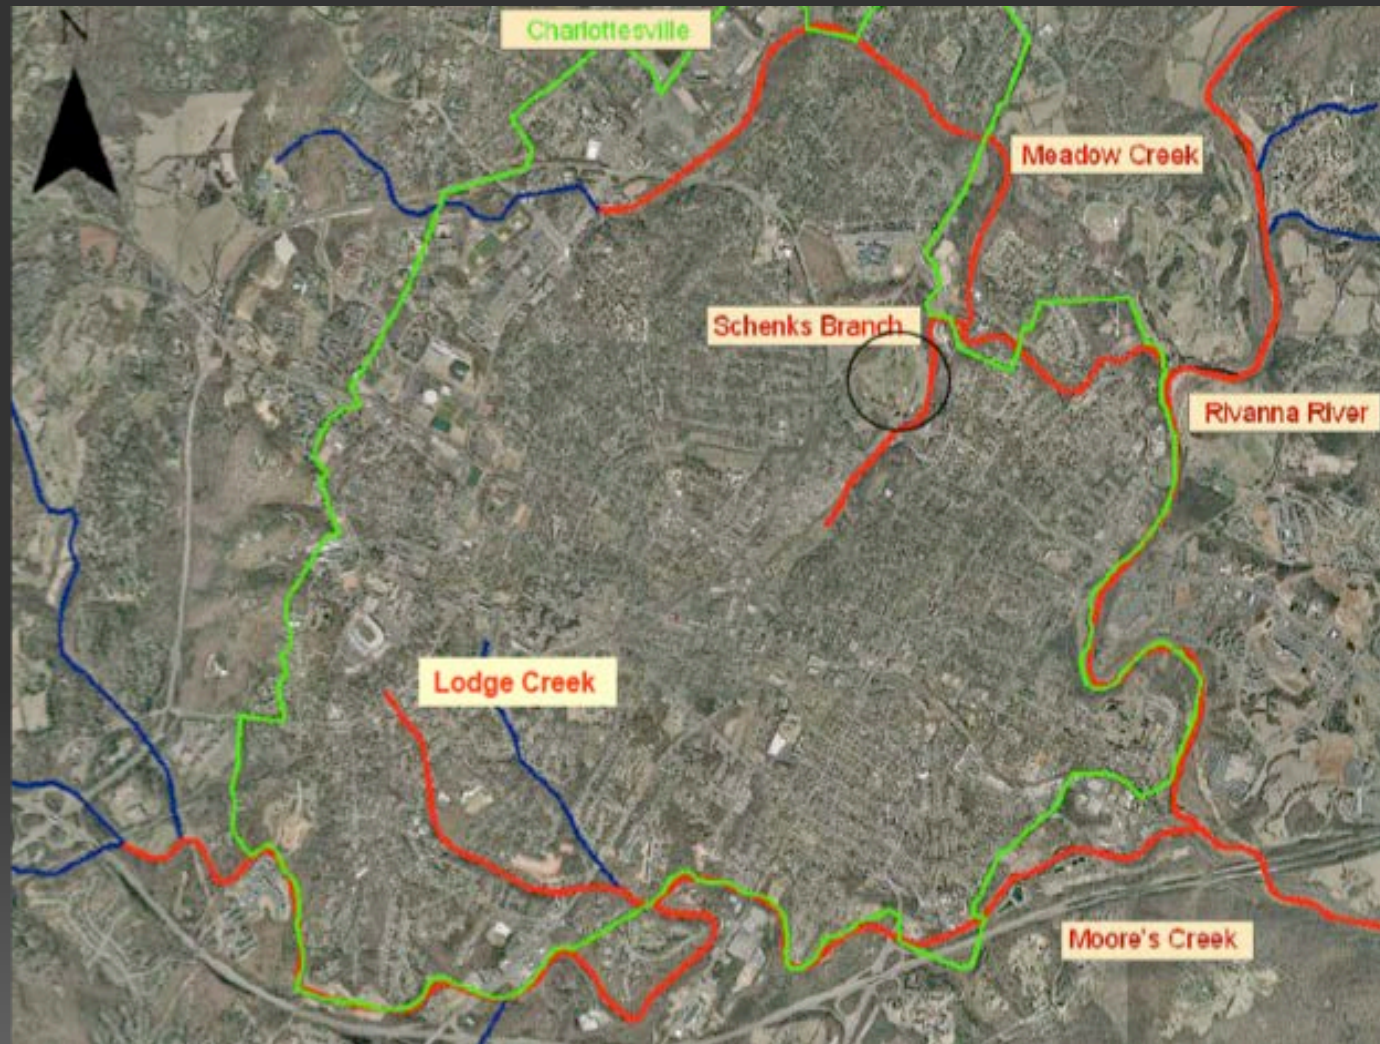
- McIntire East located within Schenks Branch Watershed

- Main waterway within park: Schenks Branch and tributary to Schenks (X-Tributary)

- 2500 linear feet
- Avg. depth: 7 inches
- Avg. width: 6 feet
- Drainage area: 2.2 square miles

- Intermittent, channel is defined by storm flow (not perennial)

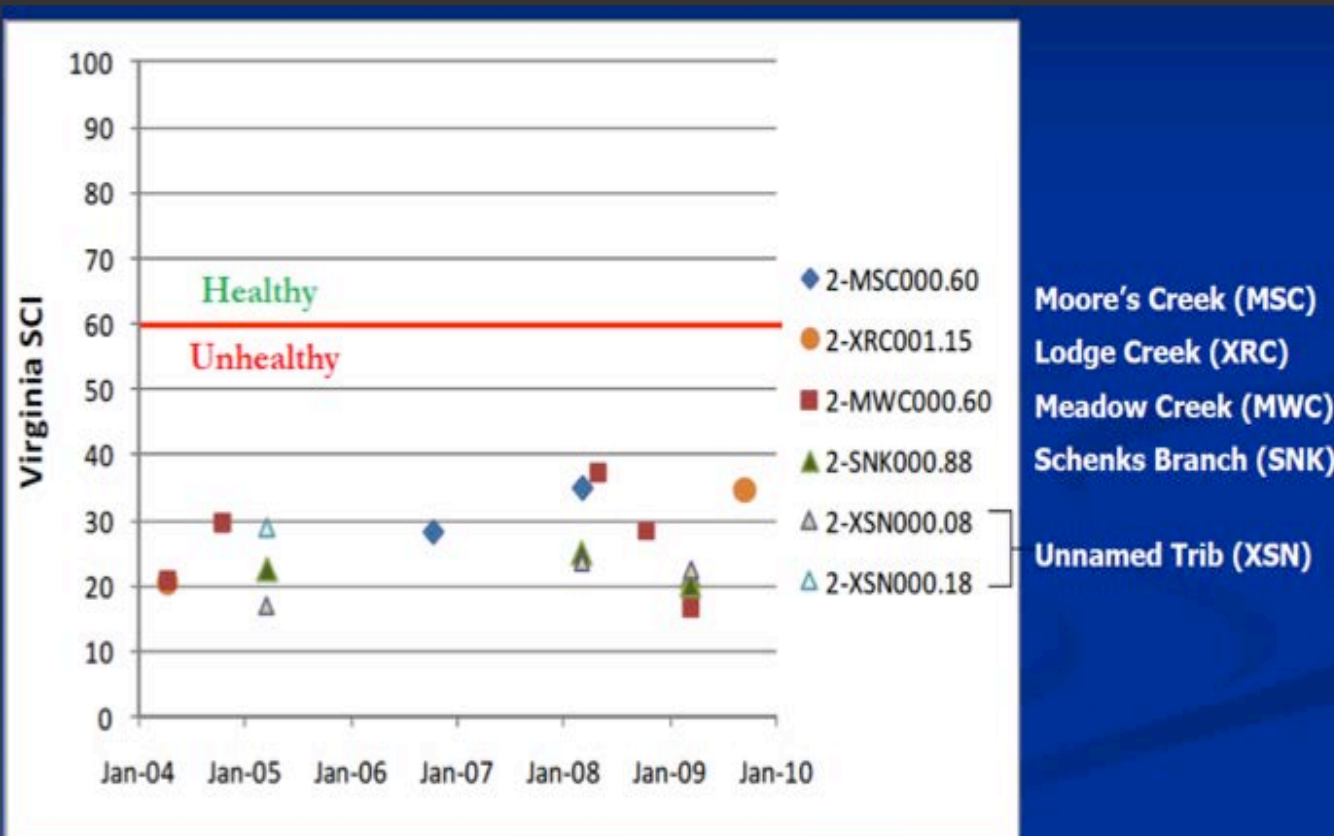
Graph Source: VT-BSE 2011

- Schenks Branch is impaired; TMDL plan is in development

- Impairments from hydraulic modifications, excess sediment and chlordane
- Percent impervious surfaces in watershed:
  - Schenks: 32.6%
  - Lodge: 30.7%
  - Meadow: 31.9%

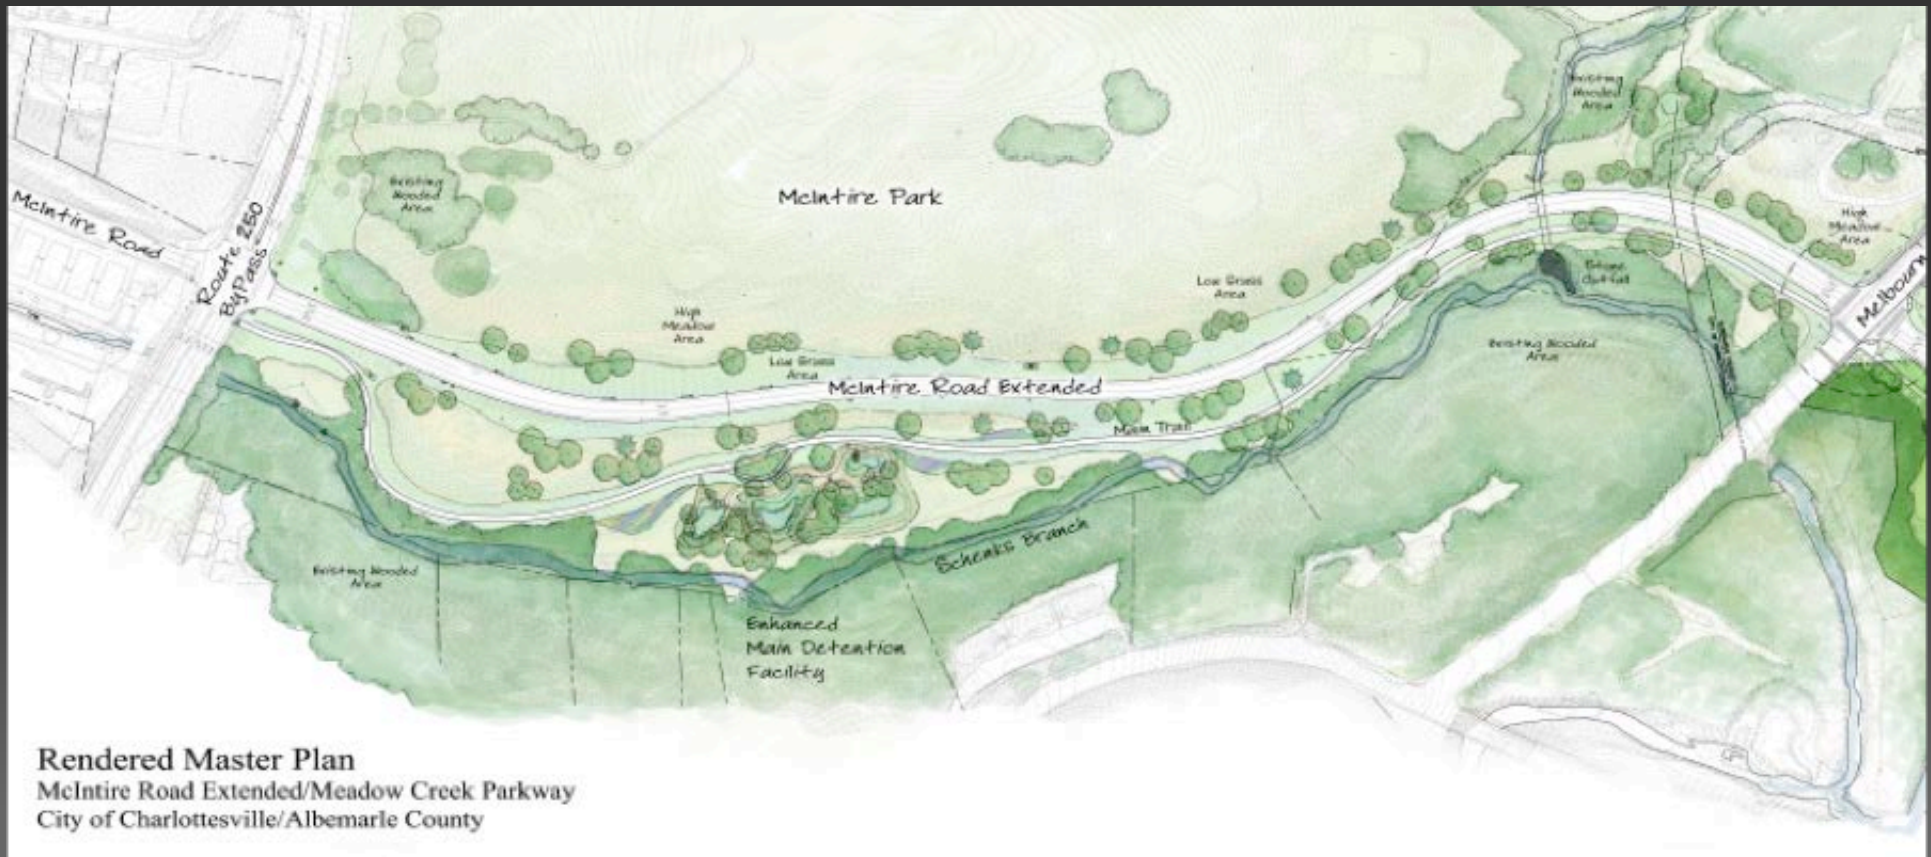
- Route 250 Interchange and McIntire Road Extended/ Meadow Creek Parkway
  - Potential impacts to Schenks Branch and X-Tributary
  - Additional impervious surfaces
  - Botanical garden would further affect these waterways

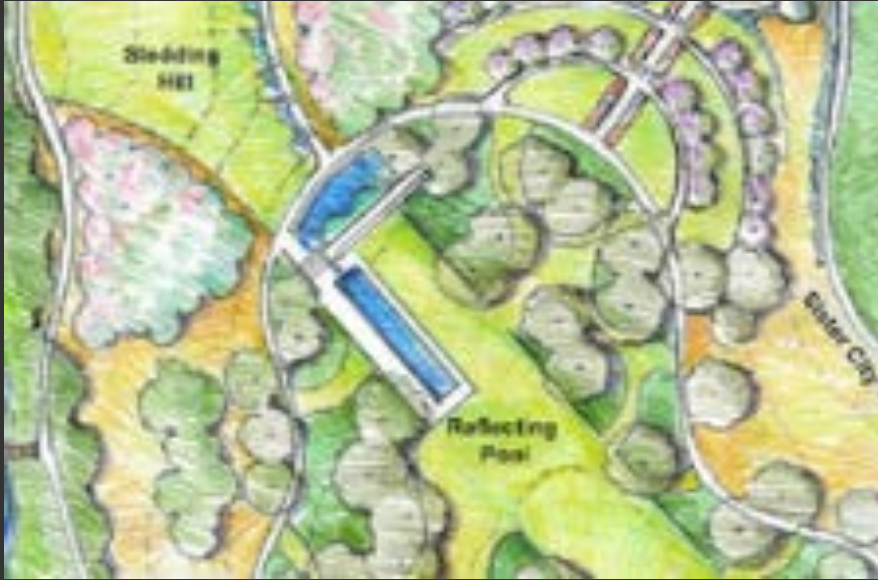
Alternative 1

# Water - Increased Consumption

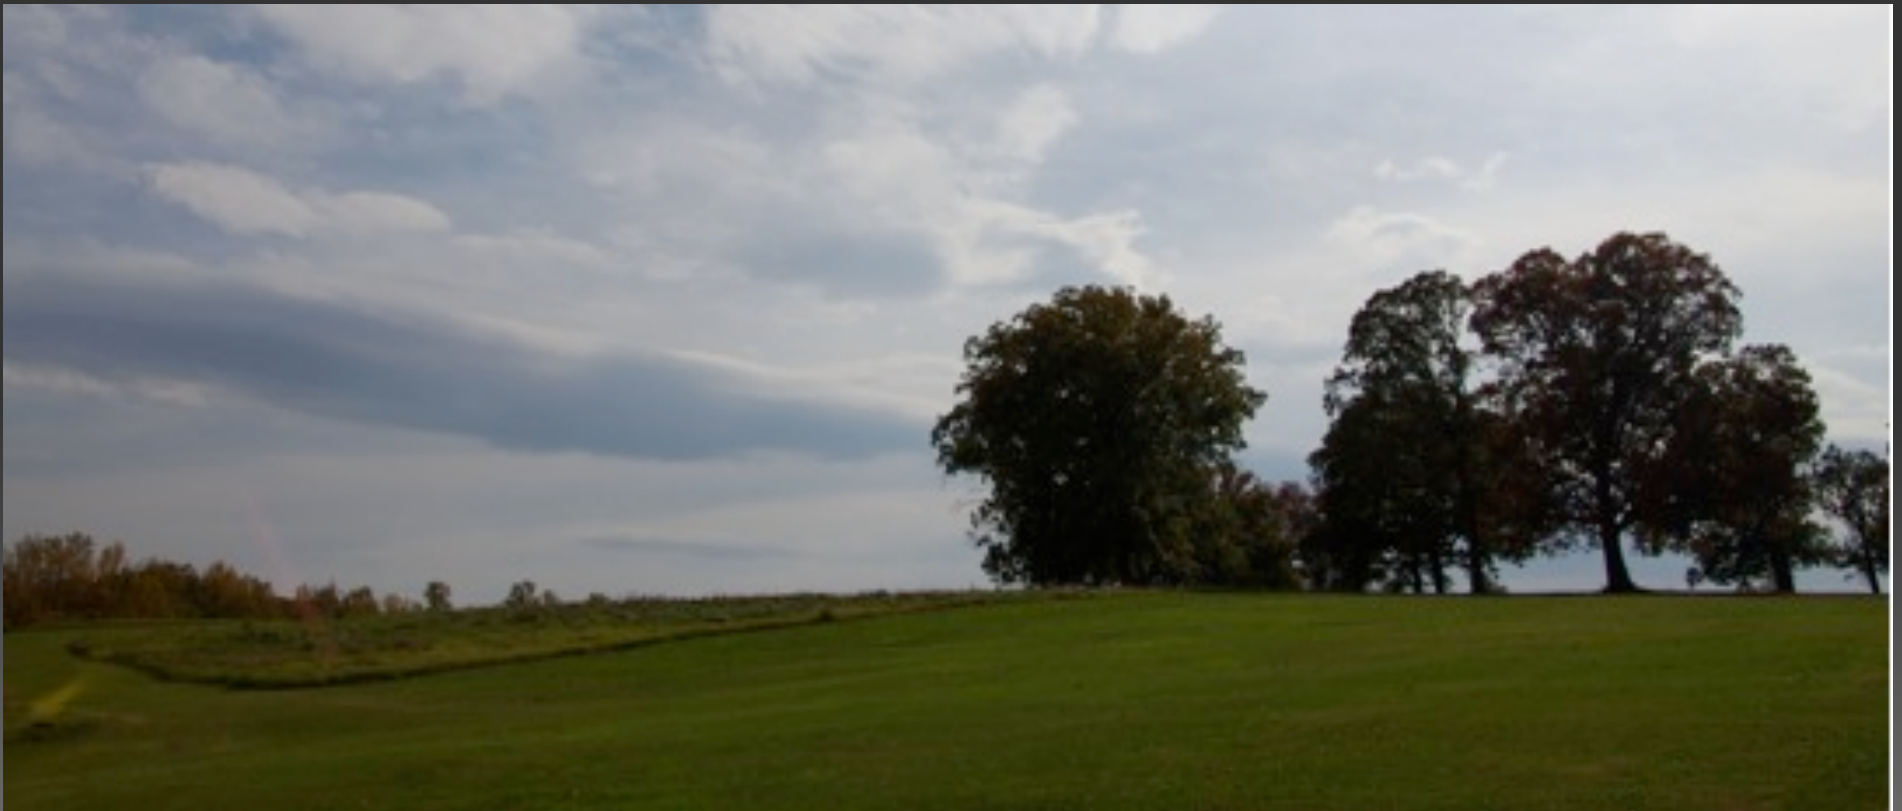
# Visual - Existing Conditions

- Existing character is that of pastoral golf course and municipal park
- Maintained lawn and meadowland dominate rolling terrain, and a grove of mature oak trees crown the hillside

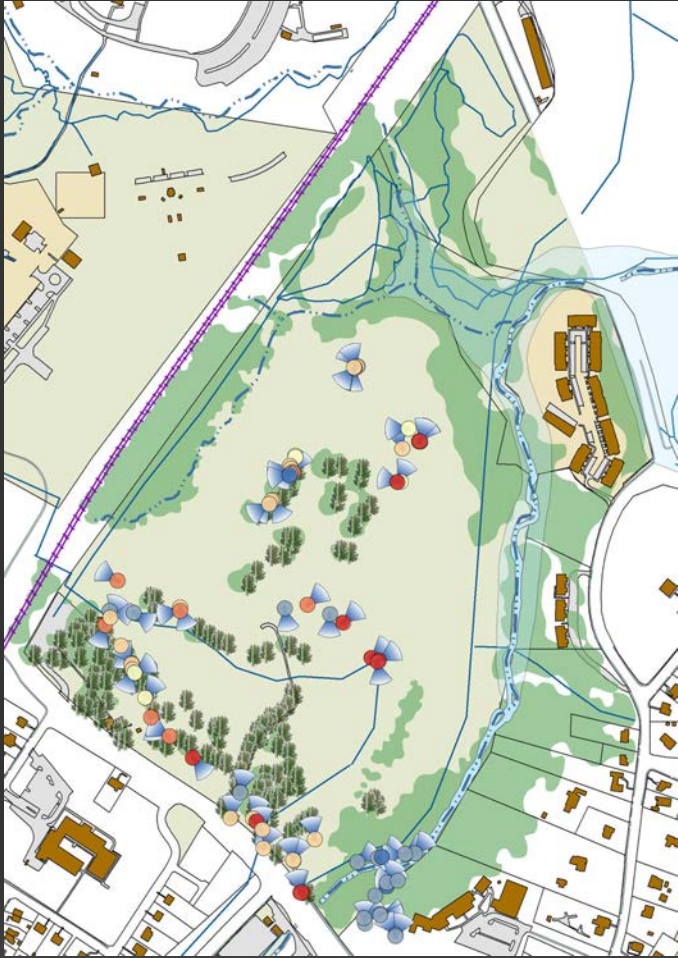
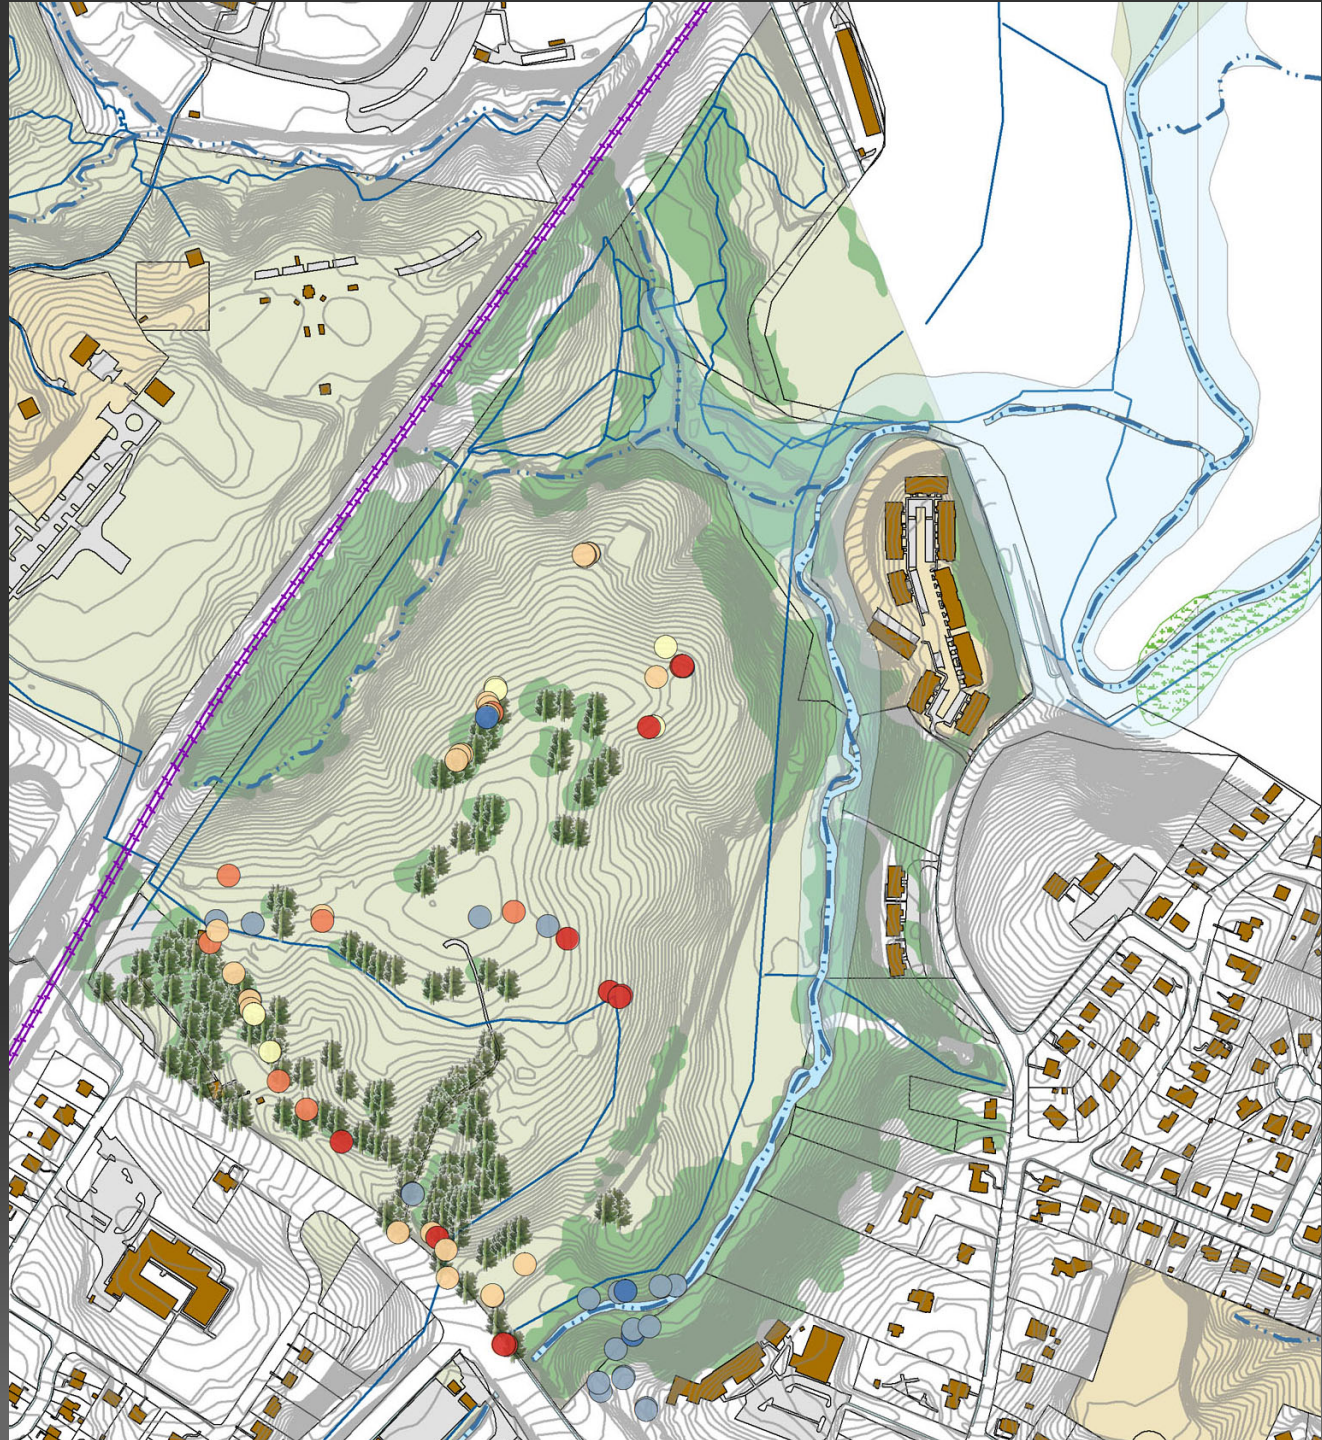
- 0 - null rating
- 1 - very good views, preserve
- 2 - good views, preserve if possible
- 3 - moderately good views, could be used to project's advantage
- 4 - poor views, screen if possible
- 5 - very poor views, must screen
- direction of view

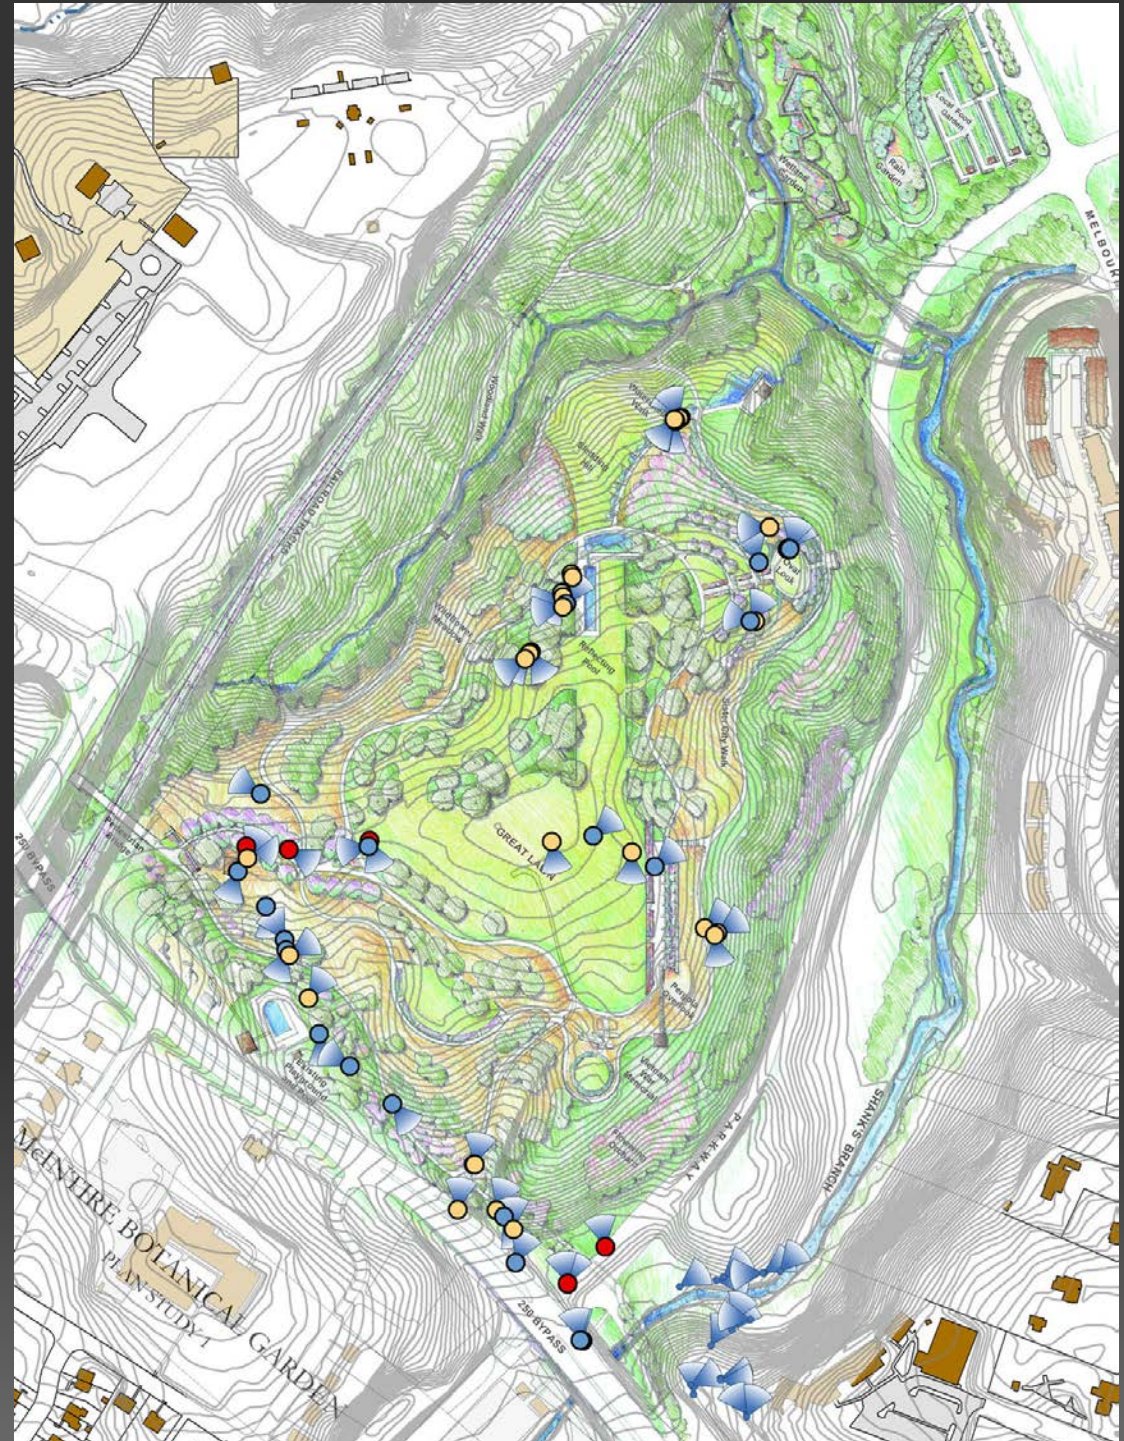
- Baseline points overlaid with alternative plans
- Team made generalized predictions to determine impacts of views
- This plan will create new visual interest from seasonal ornamentals, day-lighting streams, and carefully planned pathways

- 1 - Improved view
- 2 - No significant change
- 3 - Potentially degraded view
- ▲ Out of study area
